Manhole Inspection Summary

Manhole # S21K__051MH

Insp Date: **9/26/07 11:53 AM**

Location Address: **1735 PRATT ST**

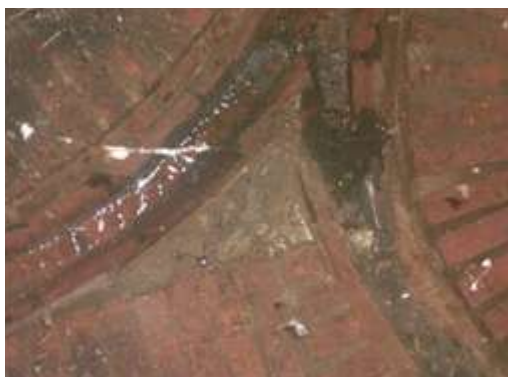
Defect 5

Condition: ☐ Sound ☐ Cracked ☐ Root Intrusion ☒ **Deteriorated** ☐ Leaks ☐ Debris

DETERIOATED BENCH

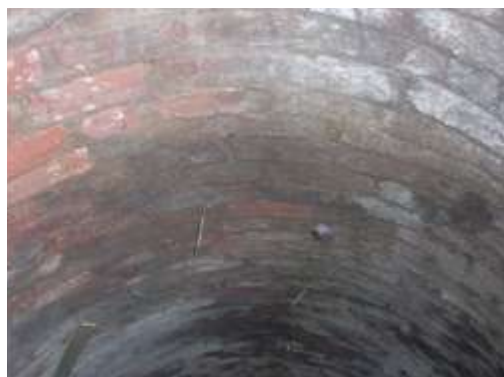
Defect 4

Infiltration: ☐ None ☐ Joint ☐ Cracks ☐ Mortar ☐ Roots ☒ **Wall**

INFILTRATION OF THE CORBEL

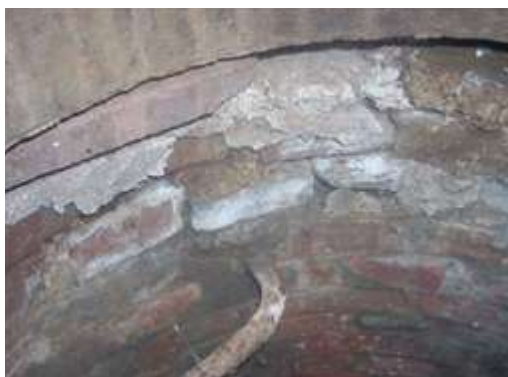
Defect 3

Condition: ☐ Sound ☐ Cracked ☐ Root Intrusion ☒ **Loose Brick** ☒ **Deteriorated**

Condition: ☐ Sound ☐ Cracked ☐ Root Intrusion ☐ Loose Brick ☒ **Deteriorated**

DETERIORATION OF CHIMNEY AND CORBEL

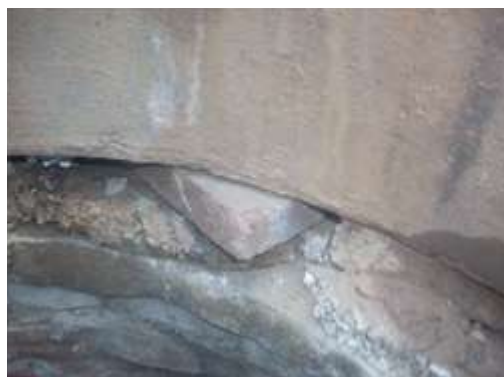
Defect 2

LOOSE CHIMNEY BRICKS

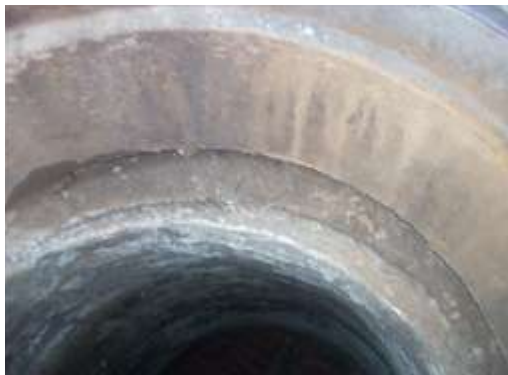
Defect 1

Offset: **2** (in.)

FRAME OFFSET
